**Pre-Dam Removal Geomorphic Monitoring
Penobscot River Restoration Project**

Alice R. Kelley

School of Earth & Climate Sciences

September 2012

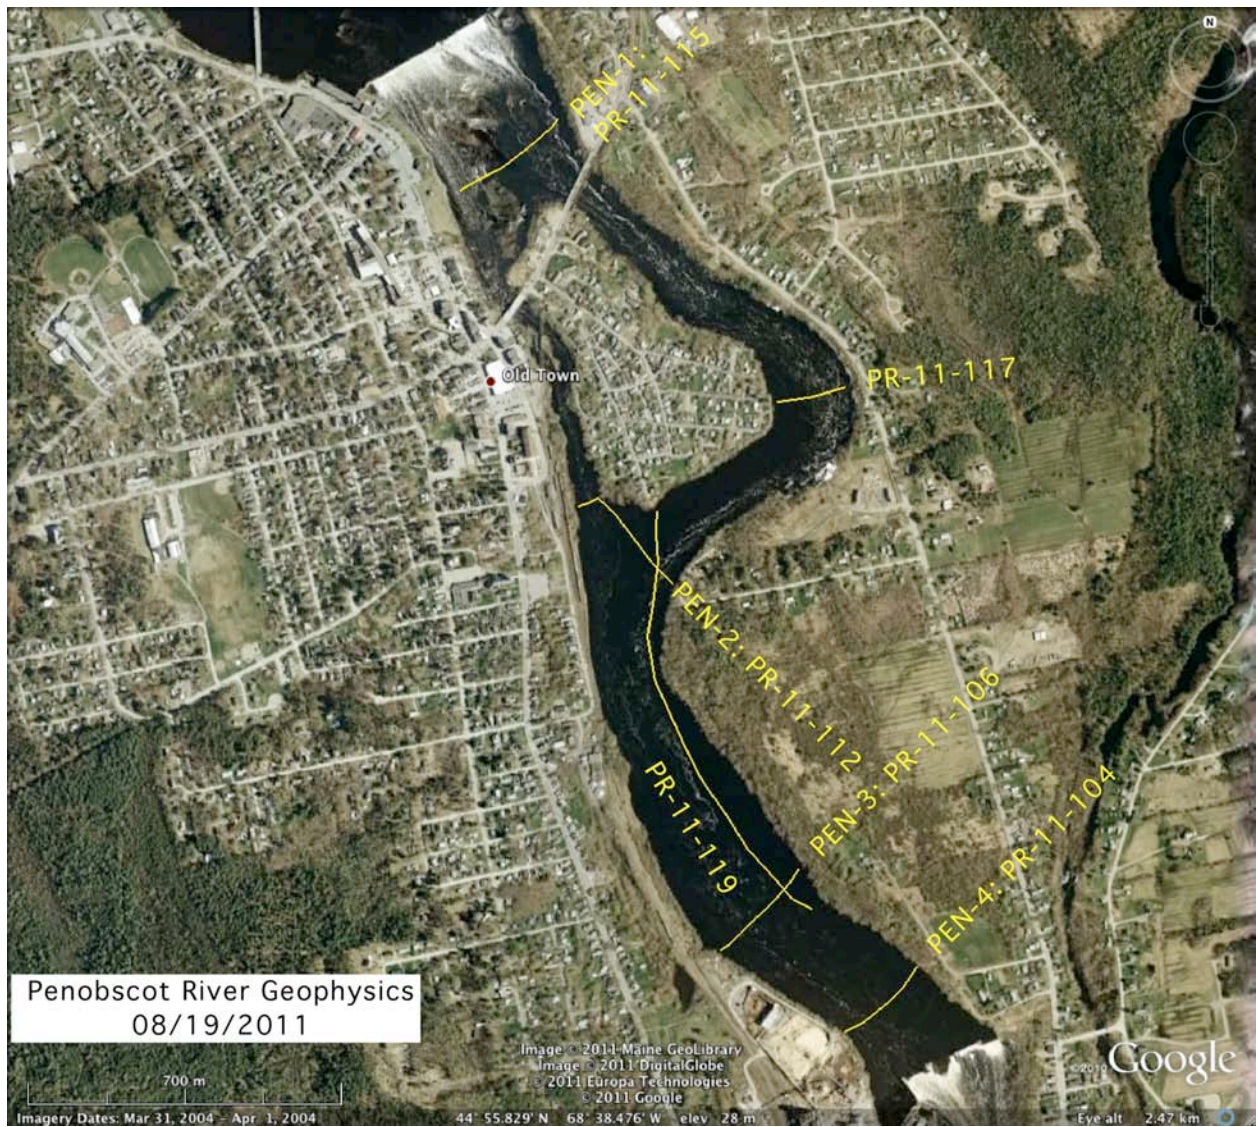
Figure 8 – Geophysical survey 08/19/2011 along transect lines in the Great Works impoundment, Penobscot River, Old Town.

Surveys were conducted along the previously established transects in the Great Works impoundment from the dam up to the rapids at the toe of the Milford dam (Figure 8). Conditions were clear, with nearly calm winds, and a moderate river flow. The most difficult pre-cruise planning was to find a calm weather day with water levels high enough for safety and efficient data collection, but with navigable river currents. Navigation was recorded automatically onto chart paper of the Bathy500DF, and a supplementary paper record was kept by hand in the skiff at one-minute intervals. A hand log of the time and shot-point numbers for the GPR in the canoe was recorded

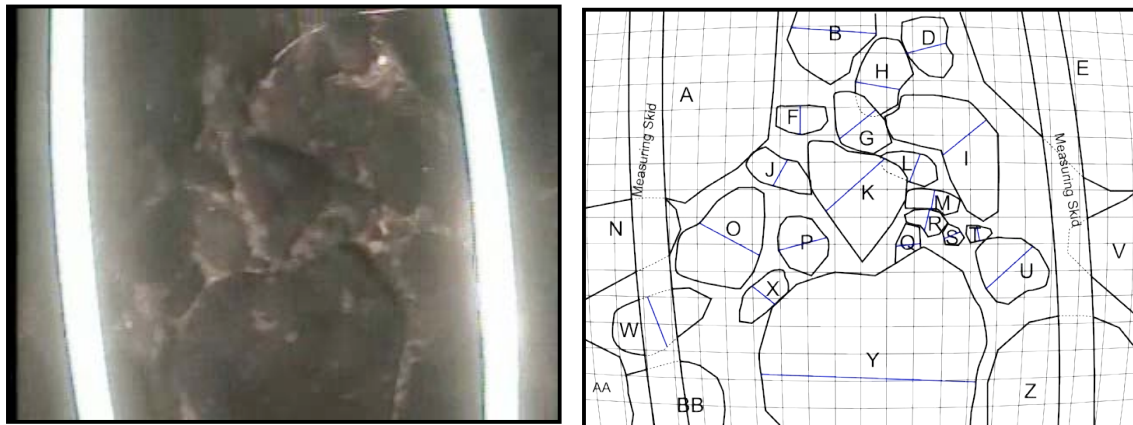
Figure 12: Still image extracted from video camera tow on left (PEN 4, 8th minute). Measuring grid and locations of clast measurement on right.

monumented cross sections, and showed that the channel bottom was dominated by coarse clasts (mean = 4.9 cm) with a sand or silt matrix. Fine-grained deposits, when encountered, were associated with channel banks. While this information does not characterize the entirety of the river channel, it suggests that coarse clasts with a fine-grained matrix is the dominant channel environment in examined area, with the exception of locations immediately adjacent to channel-side sand deposits, such as eskers. Figure 12 shows a representative image of a still image from the channel bed of monumented cross section PEN 8 with the measuring grid overlain on the image and the location of clast diameter measurements. While the measuring scale in this image is washed out, the camera distance from the scale remained at a fixed distance for the entire survey, allowing use of a clear view of the scale to be applied to all images from the same survey. The accompanying Table 6 presents the clast sizes measured at that location. Table 7 contains the image description notes for the image.

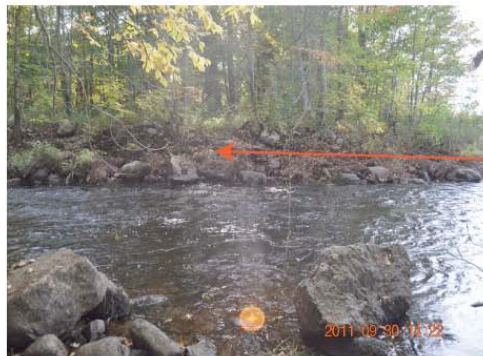
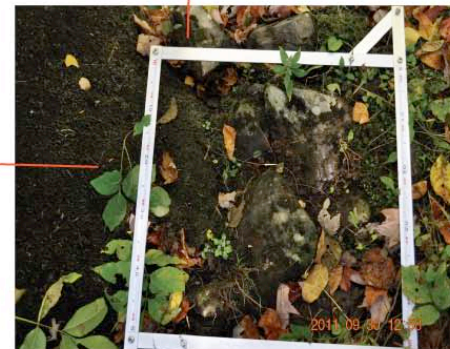
Clast	Intermediate Diameter (cm)	Notes
1	23.5	Clast outside of field of view
2	5.4	Clast outside of field of view
3	1.8	
4	8.5	Clast obscured by clast 5
5	16.1	
6		Clast obscured by clast G
7	1.6	
8	5.6	
9	16.8	
10	5.5	
Mean: 9.4 Standard Deviation 7.2

Figure 13: Bank sediment characterization data table, cross section sketch and images.
